Manhole Inspection Summary

Manhole # S43W1_014MH

Insp Date: **3/27/09 5:12 PM**

Location Address: **709 Chesapeake Ave.**

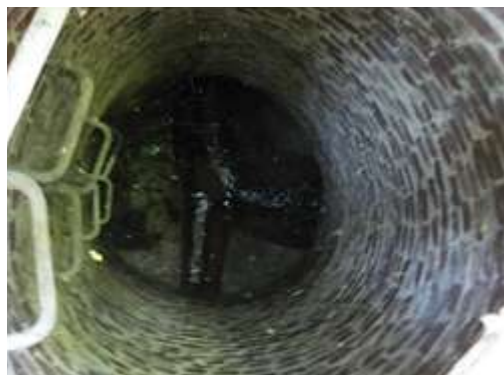
Top View

Cover

Condition: **Sound**

Condition: ☒ Sound ☐ Cracked ☐ Leaks

Condition: ☒ Sound ☐ Cracked ☐ Root Intrusion ☐ Loose Brick ☐ Deteriorated

Condition: ☒ Sound ☐ Cracked ☐ Root Intrusion ☐ Deteriorated ☐ Leaks ☐ Debris

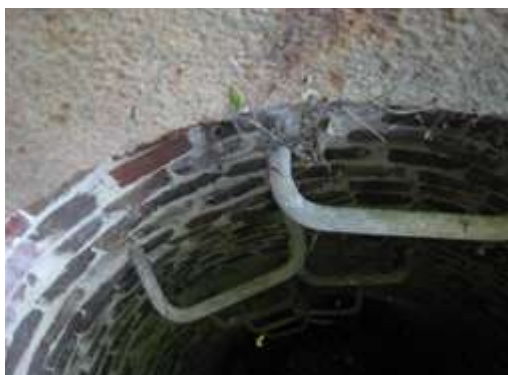
Steps

Count: **8** Missing: **0** ☐ Corroded

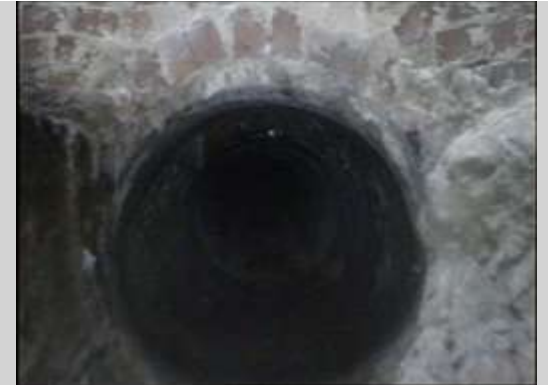
12 O'Clock Outflow

24 in. Circular Gravity Sewer
Pipe Out @ 12 O'Clock

Pipe Height: **26.4** (in.) Rod and Bar (Angled)
Pipe Material: **Clay** ☐ Pipe Lined
Invert Depth: **12.80** (ft.) Flow Characteristics: **Slow**
Deposits: ☒ None ☐ Mud ☐ Sludge ☐ Debris ☐ Grease
Silt Depth: (in.) Deposits Extent:
Infiltration: **None** Pipe Seal Cond: **Sound**

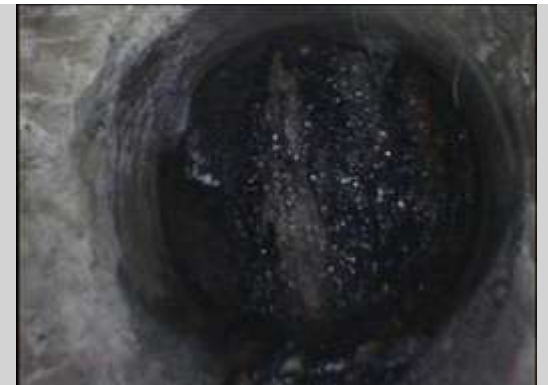
3 O'Clock Inflow

24 in. Circular Gravity Sewer
Pipe In @ 3 O'Clock

Pipe Height: **24** (in.) Rod and Bar (Angled)
Pipe Material: **Clay** ☐ Pipe Lined
Invert Depth: **12.40** (ft.) Flow Characteristics: **None**
Deposits: ☒ None ☐ Mud ☐ Sludge ☐ Debris ☐ Grease
Silt Depth: (in.) Deposits Extent:
Infiltration: **None** Pipe Seal Cond: **Sound**

Connects To: **Stub connection / abandoned**

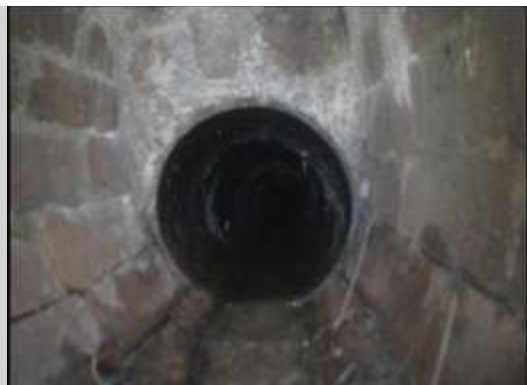
6 O'Clock Inflow

10 in. Circular Gravity Sewer
Pipe In @ 6 O'Clock

Invert Depth: **12.10** (ft.) Flow Characteristics: **Slow**

Infiltration: **None** Pipe Seal Cond: **Sound**

Connects To: **Dead End**
